**Party Submission by FedEx Ground Package System, Inc.**

NTSB No. HWY20MH002  
Occurrence Date: January 5, 2020  
Location: Mt. Pleasant, Pennsylvania

Submission Date: July 23, 2021

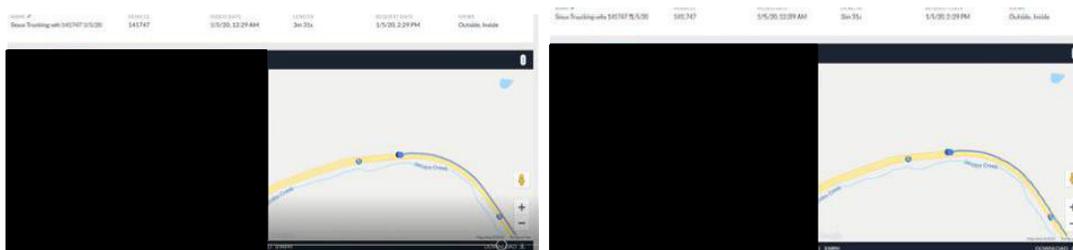
<sup>2</sup> Certain critical aspects of the subject accident were recorded on a Video Event Data Recorder (VEDR) installed in the FedEx Ground tractor. The VEDR video captures several minutes prior to the accident, the first impact between the FedEx Ground tractor and the motorcoach, and the subsequent impact with the motorcoach caused by the UPS #1 tractor. That video is the subject of the NTSB’s Video Study report. Notably, missing from the Video Study report is any mention of the UPS #1 tractor and that subsequent impact. The report acknowledges the limits of the study, “[t]he goal of this study was estimating the speed of the truck, the speed of the motorcoach, and the response time of the truck driver.” FedEx Ground submits that omission of any reference to or description of the UPS impact is material as that portion of the footage demonstrates the greater, more harmful force of the UPS impact. Specifically, when the UPS tractor impacts the FedEx Ground trailer, papers not previously dislodged by the first impact fly throughout the FedEx Ground Driver’s cab. The video also captures that at the time of the UPS impact, the speedometer reading on the VEDR video for the FedEx Ground truck went from 0 to 10 mph. Screenshots of these portions of the video are included, here.

The FedEx Ground Driver’s cab immediately after impacting the motorcoach the first time (on left). And the inside of the FedEx Ground truck upon impact by the UPS truck (on right):
